Cuppon

45S / 59S

Tüp Motor Kullanım Kılavuzu

## 45S / 59S Mechanical Limit Tubular Motor User Manual

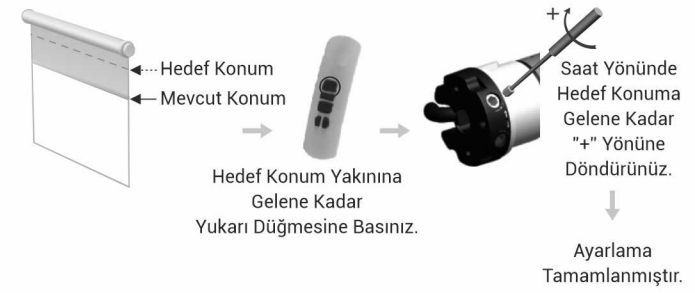
## Yukarı Limit Konumunu Ayarlama (Beyaz):

Yukarı ve aşağı limit konumu stor perdenin otomatik olarak durduğu yerdir.

⚠ Motor çalışmadığı zaman limit ayarı yapılamaz.

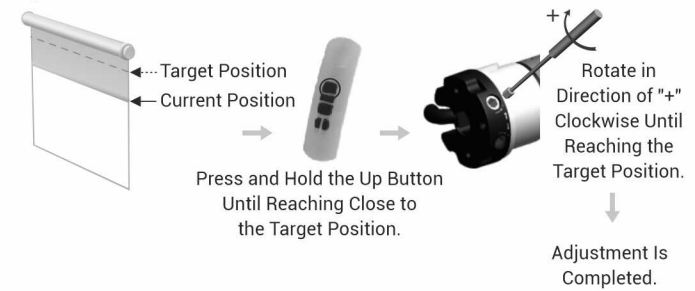
##### ⬆ Adjustment of Upper Limit Position (White):

Upper and lower limit positions are the points where the roller blind automatically stops.

⚠ Limit adjustment cannot be performed when the motor is not operating.
